Subject: Hawaii Electric Light Company, Inc.  
March 2013 Kaumana-Pohoiki 6500 Line Events

## **March 2013 Kaumana-Pohoiki 6500 Line Events**

Prepared by HELCO Distribution Department

4/30/2013

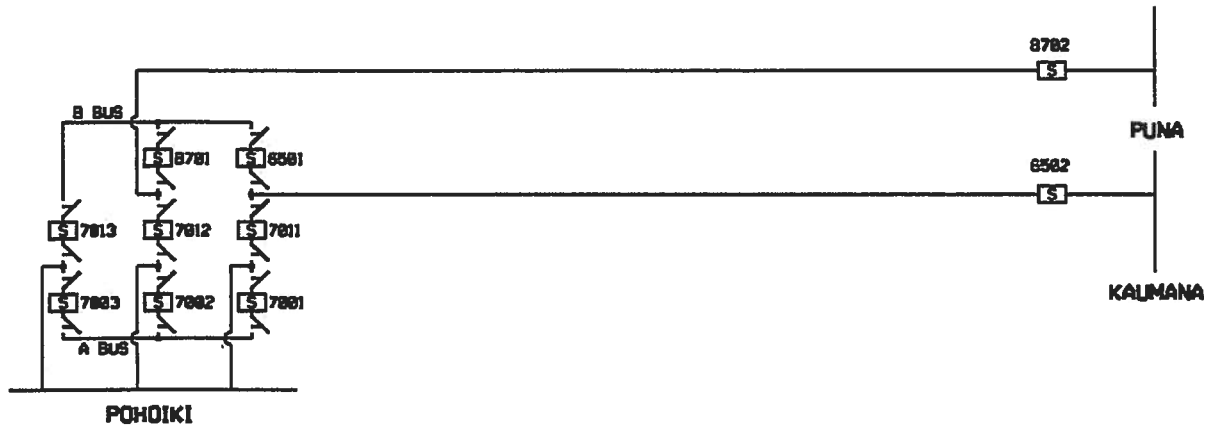
#### Single Line Diagram of 6500 and 8700 line

At 15:53:48, CBs 6501/7011 at the Pohoiki substation and CB 6502 at the Kaumana substation opened again, along with the Puna substation CB 8702 due to a fault on the 6500 transmission line. This disconnected PGV's 38 megawatts of generation from the HELCO system and caused 20 circuits around the island to open automatically due to the under-frequency load shedding scheme (blocks 1 and 5). This shutdown also resulted in a controlled release of scrubbed steam from the PGV facility and triggered a response from Hawaii County Civil Defense and the Hawaii County Fire Department due to concerns from the citizens in areas close to the PGV facility. A total of 20,095 customers lost power for various amounts of time up to 15 minutes long. This event also caused PGV to vent abated steam into the atmosphere to relieve pressure on the system.

The cause of the Puna CB 8702 opening for a fault on the 6500 line was investigated immediately after the event and resolved the next morning on 3/14/13. The SEL-421 relay for the Pohoiki 8701/7012 end of the 8700 line had incorrect logic in the settings that sent a permissive signal<sup>1</sup> to the Puna 8702 relay when only one of the two breakers at Pohoiki was open. (Pohoiki 8701 was open and isolated for crews to perform maintenance.) Normally, both CB 8701 and CB 7012 must be open in order for a permissive signal to be sent. In this instance, the permissive signal was sent even though both CB8701 and CB7012 were not open. Because the permissive signal had been received, Puna CB 8702 was allowed to open when it sensed a fault, even though the fault was not on the 8700 line. This mis-operation caused PGV to be disconnected from the system when both the 6500 line and the 8700 line opened.<sup>2</sup>

**8700 Line** (Event 4). The outage of the 8700 line was traced to incorrect logic in the settings in a relay at the Pohoiki substation. The settings have been corrected and this issue is resolved. There have been two subsequent outages on the 6500 line and they did not result in a repeat of Event 4.
